JUNE 2020

ENVIRONMENTAL CONTAMINATION ON THE FORMER OSCAR MAYER PROPERTY AND SURROUNDING AREA IN MADISON, WISCONSIN

MIDWEST ENVIRONMENTAL ADVOCATES

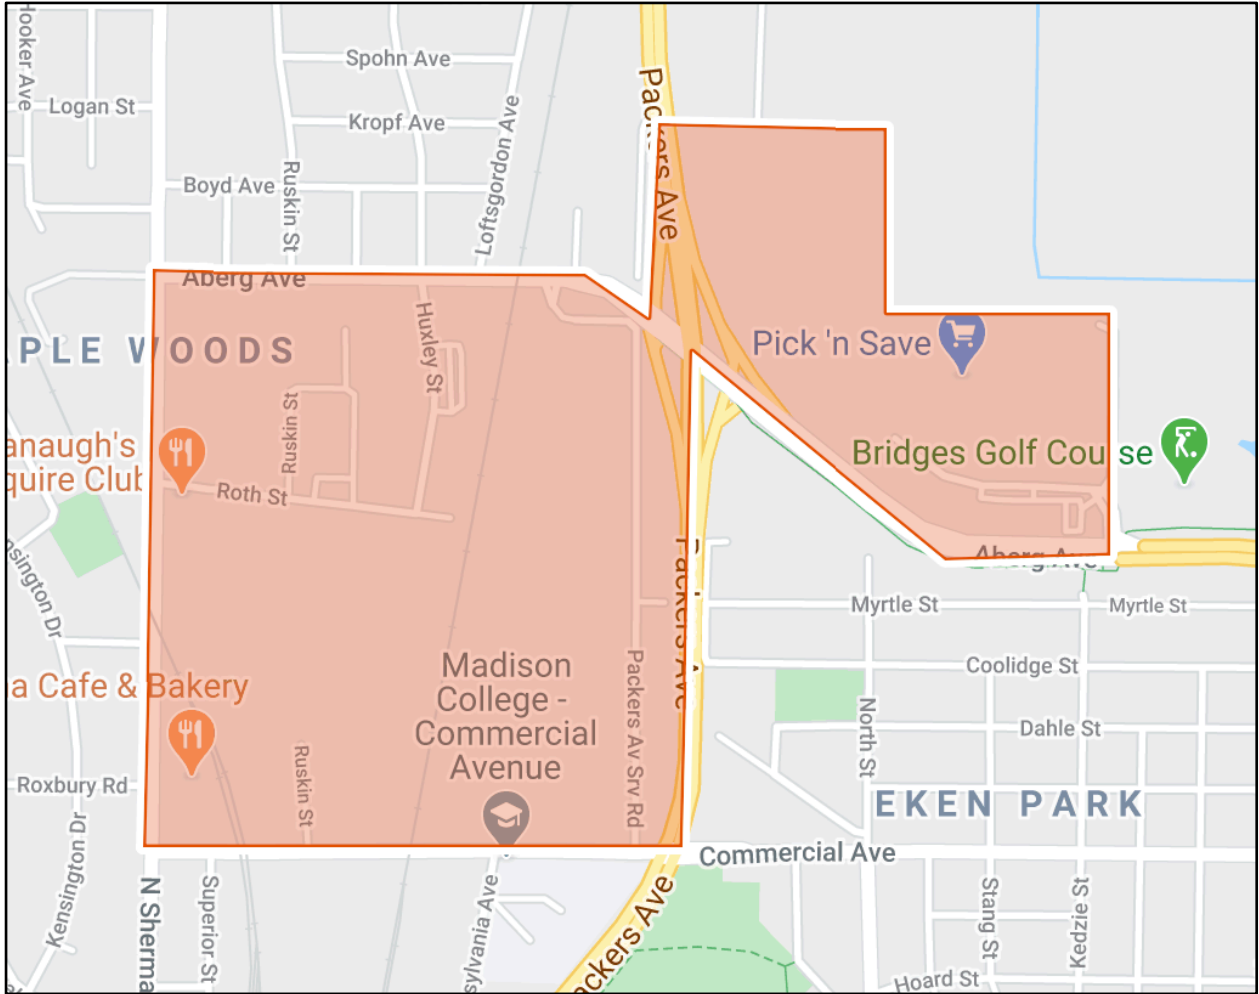
MAP OF THE PROJECT AREA

This memorandum provides a plain language summary of information related to historical and current environmental contamination on the former Oscar Mayer property located at 910 Mayer Avenue in Madison, Wisconsin and the surrounding area. Specifically, this memorandum is limited to the area between Packers Avenue, Commercial Avenue, North Sherman Avenue, and Aberg Avenue. Also included is the area to the east of Packers Avenue and north of Aberg Avenue that is bounded by Bridges Golf Course. These areas are hereafter collectively referred to as the Project Area.
